▶ EK-BM3R8S120A

EK-BM3R8S120A Instructions

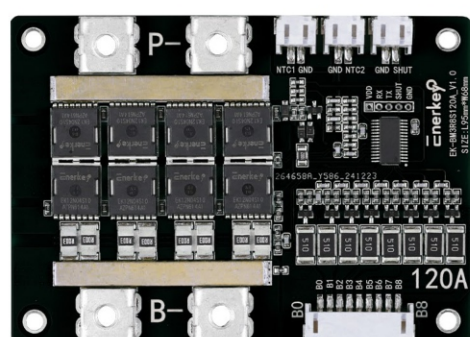
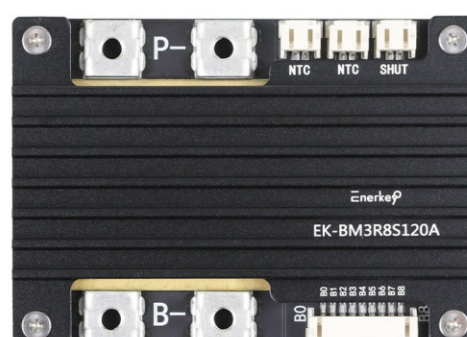
EK-BM3R8S120A Parameter Description	
Battery string	3S/4S/5S/6S/7S/8S
Size(mm)	L95*W68*T18
Weight	120g
Continuous current	120A
Peak current	300A
Temperature protect	With
Balancing	With passive balancing
Battery type	Li-ion/Lifepo4/Lto/SIB
Base material/Surface treatment	FR-4 / Lead-free spray tin
Remark	Charging and discharging in same port
Feature	Automotive-grade MOS, 2oz thickened copper foil and copper strip current sharing, high precision, ultra-low internal resistance, ultra-low heat generation Overcharge protection, over-discharge protection, over-current protection, over-temperature protection, short-circuit protection, anti-static protection, dust and moisture protection, etc.
Application	Battery packs for electric vehicles, electric motorcycles, tricycles, sightseeing vehicles, outdoor energy storage, home energy storage, etc.

3S	4S
Wiring diagram			
Wiring precautions	<p>①. Installing the protective board requires a certain amount of technical electronic knowledge</p> <p>②. Please solder the battery voltage collection line to the protective plate first, and then install it on the battery pack to fix it Follow the order of welding from low to high, from B-..B1..B2</p> <p>③. The connection between the battery terminal B- and the protection board terminal B- should be short and thick, otherwise it will cause the protection board to charge and discharge in advance and malfunction. You need to use thick wires when wiring P+/P-. Wires that are too thin and too long will burn the board!</p> <p>④. After connecting the battery, please pay attention to the insulation protection of the product to avoid short circuit when the power is on</p>		
Frequently Asked Questions	Phenomenon	Solution	
	After the protective board is installed, No output or wrong output voltage	<p>① Activate the protection board: Connect the charger to power on or short-circuit P- and B- for 2-3 seconds.</p> <p>② Then measure whether the output voltage is normal; The wiring order is wrong: measure whether the voltage of each battery string is normal.</p>
